## Keeping water out of federal court.

*(Building problems are not always what they seem.)*

Building: Federal Building and Courthouse,  
801 Broadway, Hannibal, Missouri

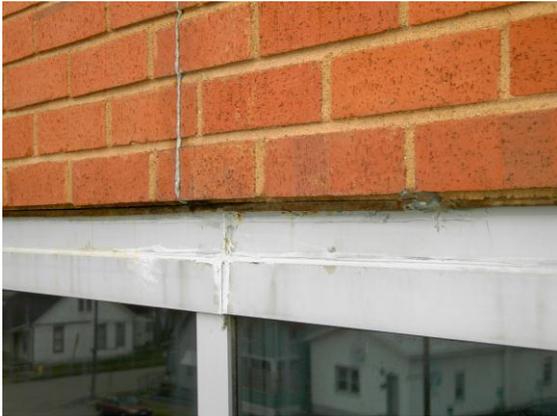
The water was said to be, and appeared to be coming in through the aluminum window tops, called heads. However, caulking had been applied to the outside of the window heads without making a difference.

Sealant applied to window heads that did not work.

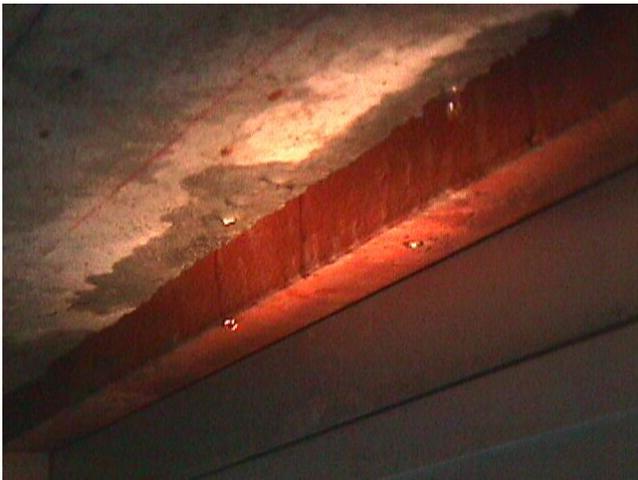
In buildings like this, there is an inch-wide cavity between the brick exterior and the building's concrete structure.

Looking up into this cavity was difficult because of the steel angles supporting the brick. However, it was possible to trace the water source to this cavity, not the window heads.

Water dripping from the wall cavity.

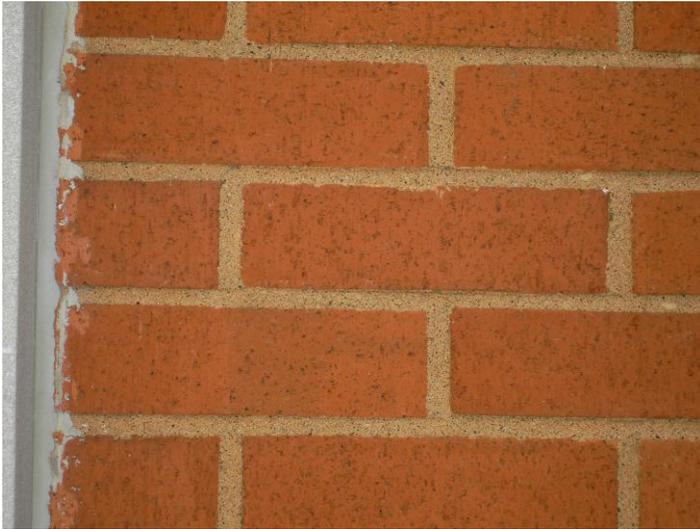
Reviewing the building drawings, deductive reasoning and testing indicated that the water was coming through the brick itself. How was this possible?

Brick can be a porous material, and this brick was absorbing a lot of water. This was confirmed by attaching a small vertical tube to the brick and sealing the connection with putty. The rate at which water in the tube drops determines permeability. In this case it was very high.

Typical brick and mortar in apparently good condition.

The porous brick on the building was treated with breathable water repellent to reduce the amount of water entering the wall. The flashing and weep holes, however, are the real line of defense against water damage.

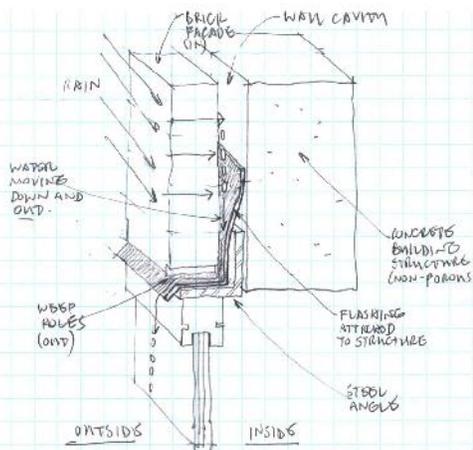
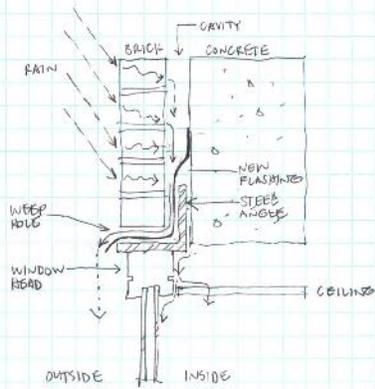
The way to deal with water inside the cavity of a wall, as we had here, is to install flashing and weep holes in the original construction. Flashing is a flexible metal or rubber sheet attached to the inside of the wall cavity and then extending out under the lowest row of brick resting on the steel angle. Weep holes are openings left in the mortar between every few bricks. They allow the water diverted by the flashing to weep harmlessly back out of the wall cavity.

Sketch – Water entering the wall is directed out by the flashing through the weep holes.

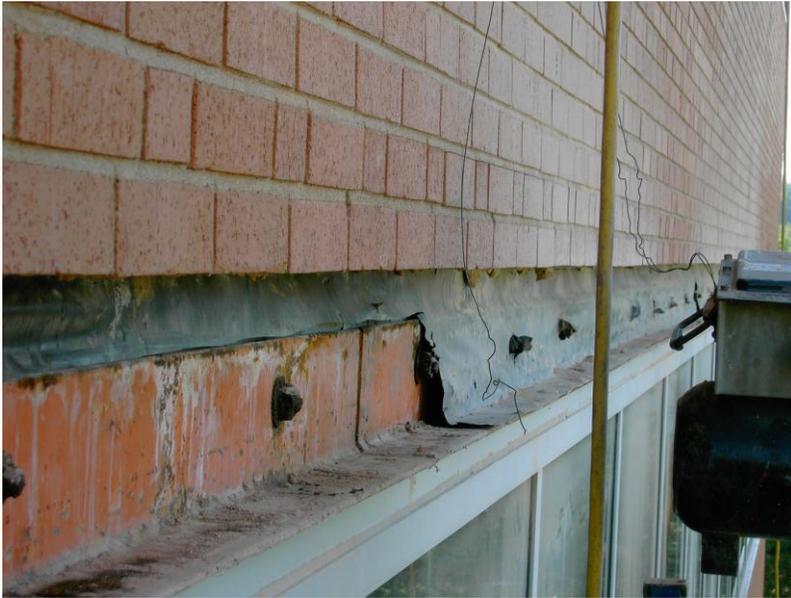
This building had flashing installed originally, but that it had deteriorated, due primarily to age.

The wall opened to reveal the deteriorated flashing.

Installing new flashing was difficult. Holes were drilled through the brick three rows above the window heads. Steel rods were set into the concrete frame of the building every few feet allowing for the removal of the three rows of brick.

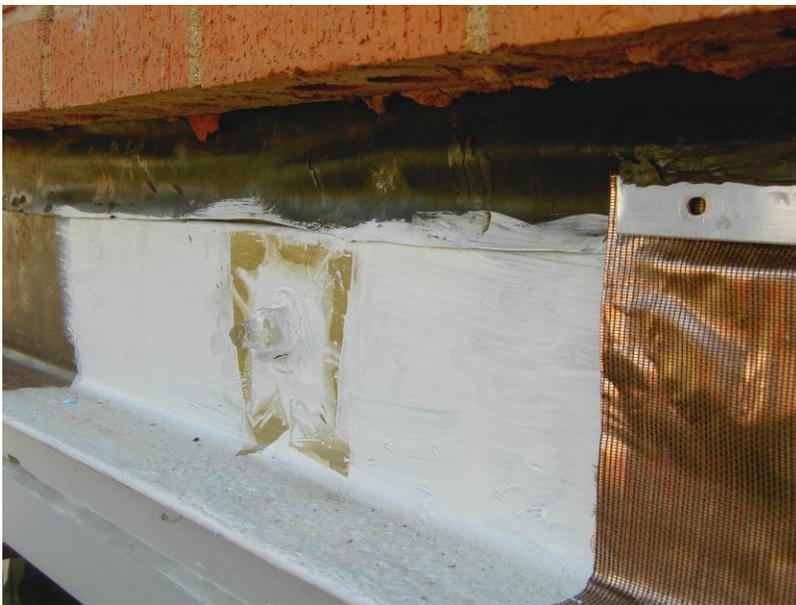
The cleaned and painted steel angle with new flashing being installed.

Laminated copper and fabric flashing was installed against the concrete frame and laped over the steel angles to the outside.

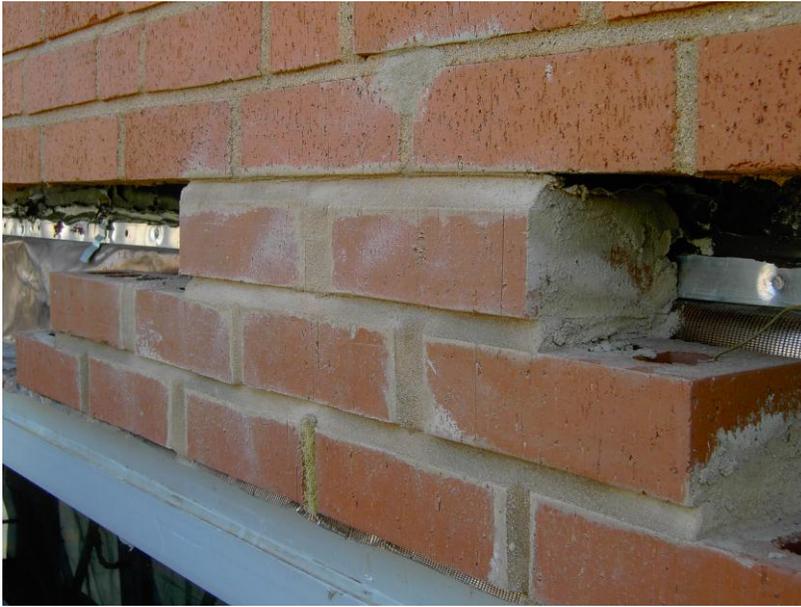
The new brick with weep holes in place of every third mortar joint.

New brick was installed, with weep holes every 24 inches, where the old brick had been removed.
